Water Compliance Inspection Report

Name and Location of Facility Inspected (For industrial users discharging to POTW, also include POTW name and NPDES permit number) Vande Hoef Dairy, LLC 2121 Stickney Island Road Everson, WA 98244	Entry Time/Date 1:15 PM 2/24/15	Permit Effective Date N/A
	Exit Time/Date 3:30 PM 2/24/15	Permit Expiration Date N/A
Name(s) of On-Site Representative(s)/Title(s)/Phone and Fax Number(s) Rodney Vande Hoef Farm Operator (360) 966-5120	Other Facility Data (e.g., SIC NAICS, and other descriptive information) NAICS 112120 - Dairy Cattle and Milk Production Lat/Lon: 48.929125°/-122.375833°	
Name, Address of Responsible Official/Title/Phone and Fax Number Rodney Vande Hoef 2121 Stickney Island Road Everson, WA 98244 (360) 966-5120	Unpermitted

Vande Hoef Dairies & Farms NPDES Inspection Report

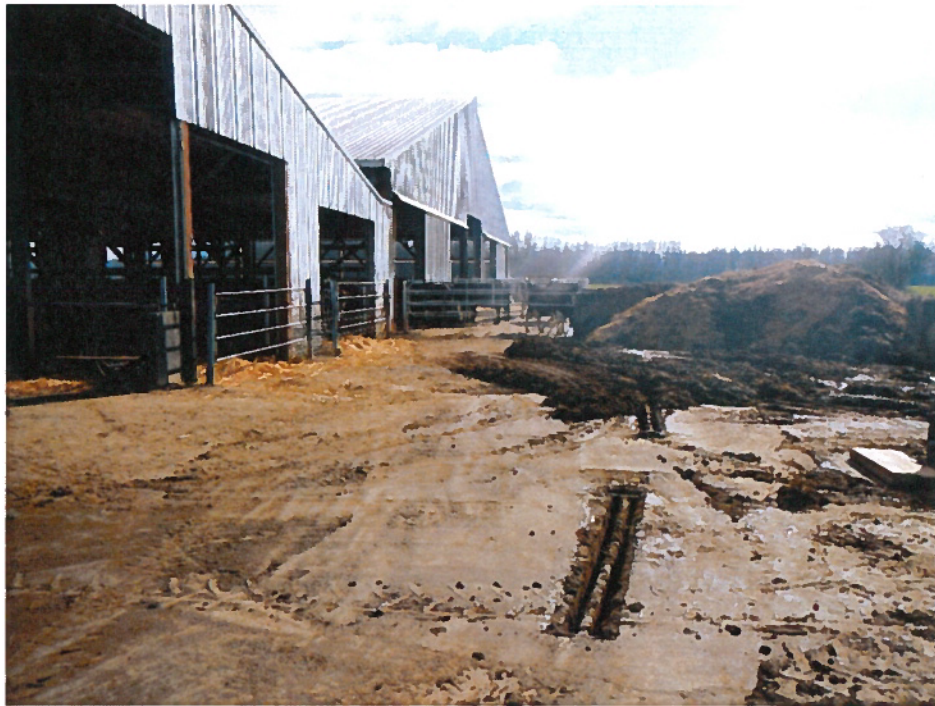
Photo 1 (DSCN0742): Southern view of the openings to the below ground storage tank and the solid waste storage area, on the west side of the barns.

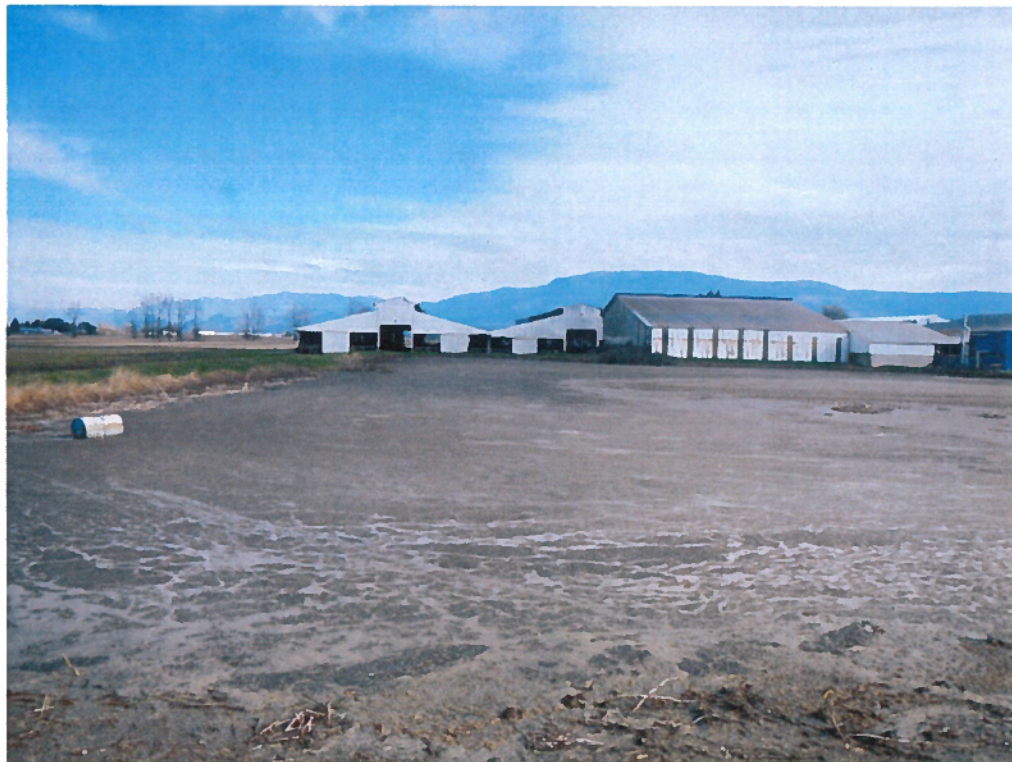
Photo 2 (DSCN0736): Eastern view of the Vande Hoef Dairy #1 lagoon (lagoon #1).

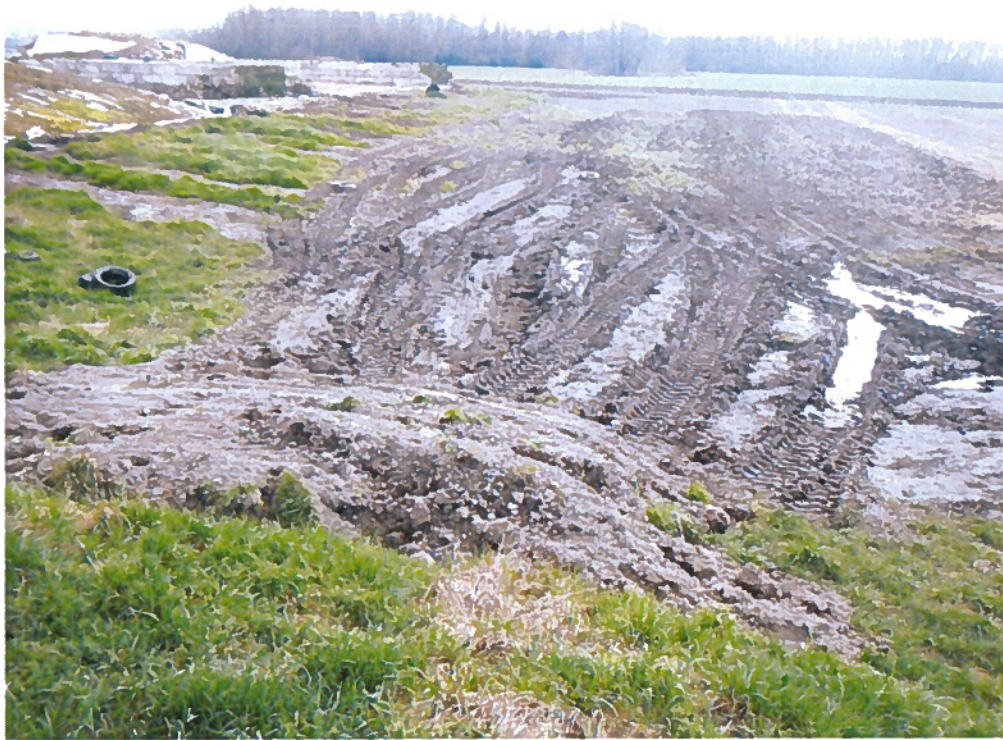
At the time of inspection, there was liquid manure on parts of the field surrounding the southwest corner of lagoon #1 (**Photos 3-5**). Mr. Vande Hoef said that, about a week prior to this inspection, moles had created a hole in the southwest corner of the lagoon which had caused a breach of the lagoon wall and the leak of liquid manure onto the field. He said that he had patched the leak by reinforcing the lagoon wall with dirt and plans to patch it further with additional dirt (**Photo 3**). I noted that there were small burrow holes present in other locations of the lagoon walls as well. Mr. Vande Hoef said that this

At the time of inspection, there was liquid manure on parts of the field surrounding the southwest corner of lagoon #1 (**Photos 3-5, Attachment B**). Mr. Vande Hoef said that, about a week prior to this inspection, moles had created a hole in the southwest corner of the lagoon which had caused a breach of the lagoon wall and the leak of liquid manure onto the field. I noted that there were small burrow holes present in other locations of the lagoon walls as well.

Photo 3 (DSCN0738): Southern view from the southwest corner of lagoon #1. According to the facility, this was the location of the lagoon hole. Soil was scraped from the field to berm the hole.

Mr. Vande Hoef said that he had patched the leak by reinforcing the lagoon wall with dirt and plans to patch it further with additional dirt (**Photo 3**). Mr. Vande Hoef said that this was the first year he had ever experienced a mole infestation like this, and he planned to use pesticides to kill the moles.

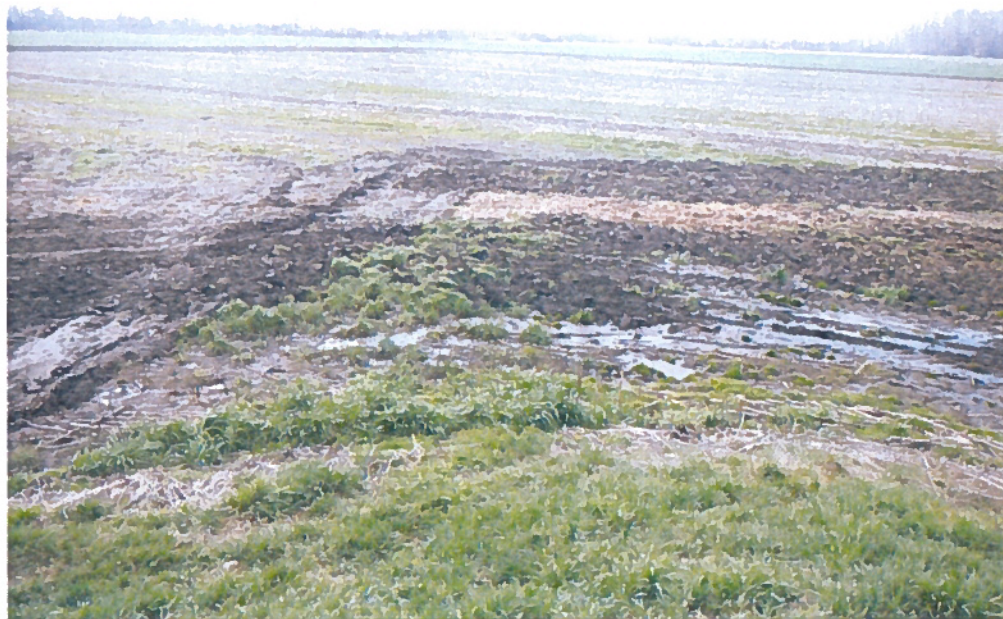
Photo 4 (DSCN0739): Southwestern view from the southwest corner of lagoon #1. According to the facility, liquid manure was present in this location from the mole hole lagoon breach event that occurred the week prior.

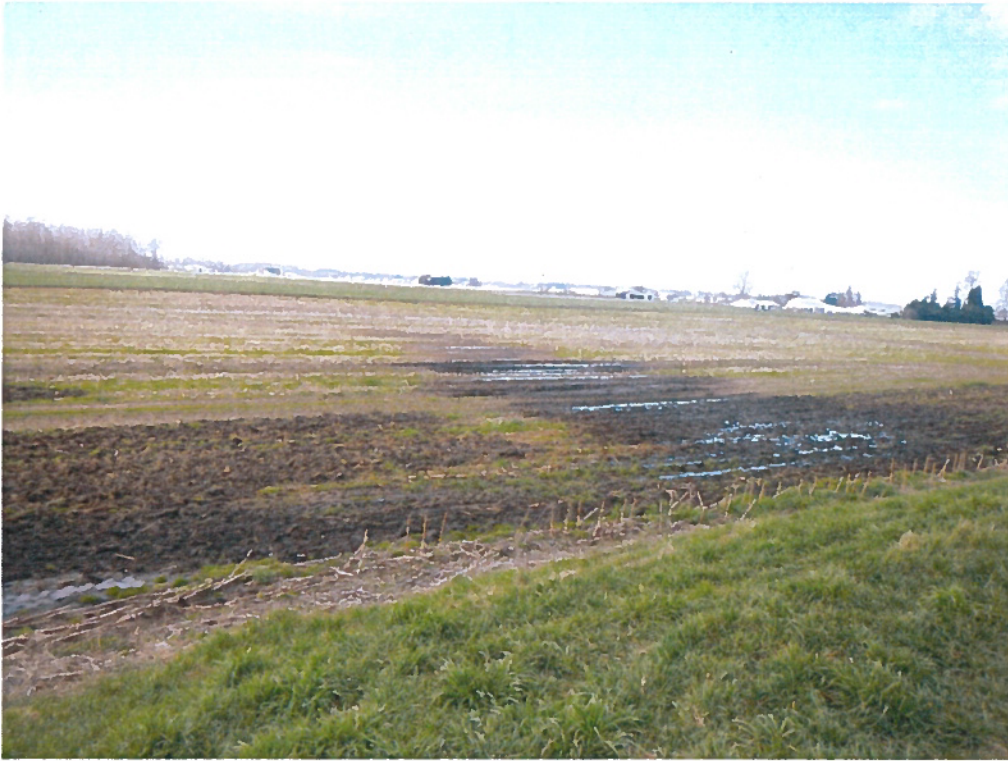
Photo 5 (DSCN0740): Southern view of the field west of lagoon #1. According to the facility, liquid manure was present in this location from the mole hole lagoon breach event that occurred the week prior.

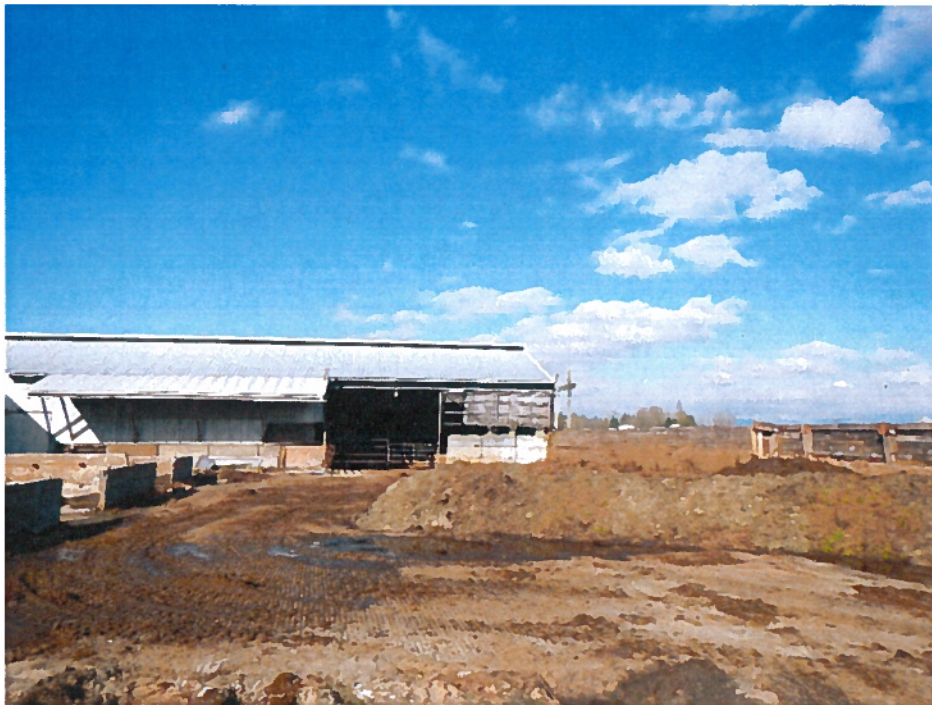
Photo 6 (DSCN0748): View of the solid waste storage area at the heifer farm.

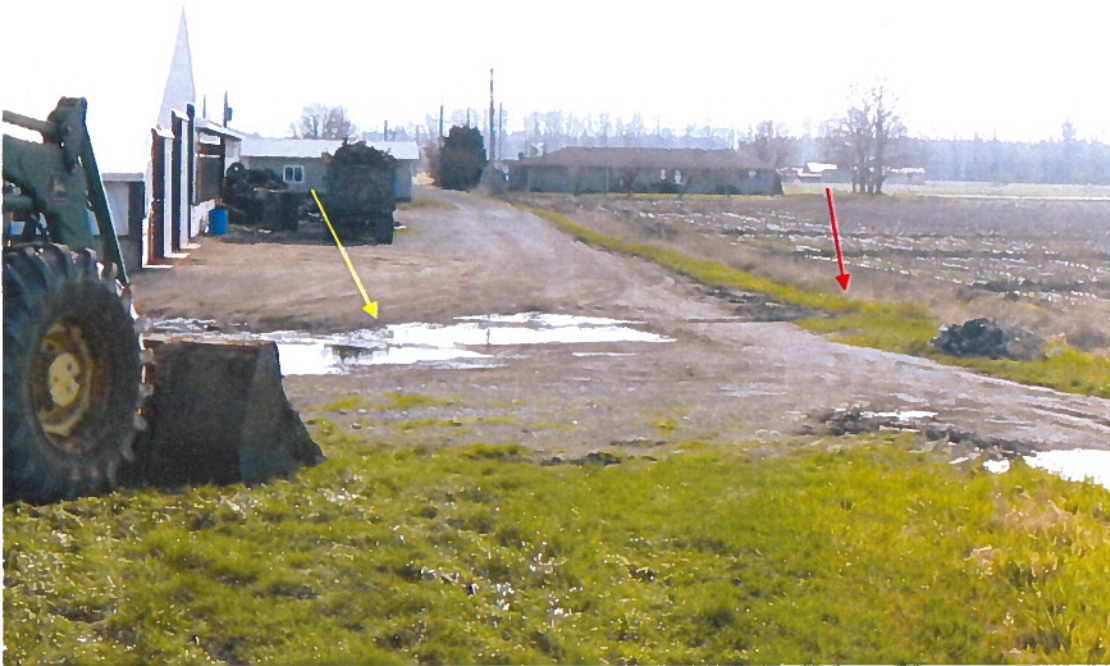
At the time of inspection, we noted that there was water ponded along the perimeter of the silage pile at the heifer farm (**Photos 7 & 8**). The ponded water stretched from the east side of the silage storage area to the northwest corner of the heifer barn and further west to within approximately 20 ft. of the ditch on the west side of the property. According to Mr. Vande Hoef, this ditch is named the Mormon Ditch and it flows north and west until it connects to the Kamm Ditch, which flows to the Nooksack River.

Photo 7 (DSCN0743): Southern view of the west side of the heifer barn. There was runoff water from the new barn roof and the silage pile that had ponded (yellow arrow) on the west side of the silage storage area and in proximity to the ditch immediately to the west (red arrow). Note this photo has been cropped and enlarged.

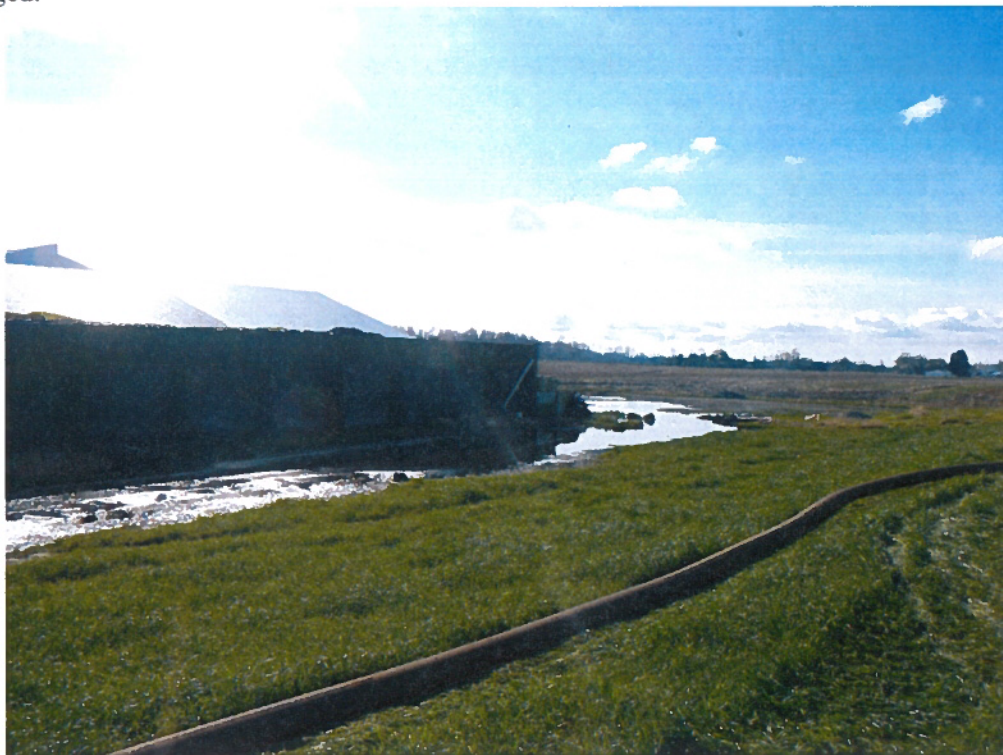
Photo 8 (DSCN0745): Southwest view of the silage storage area from the south end of lagoon #2. The runoff from the barn roof and silage pile had ponded along the perimeter of the silage storage area.

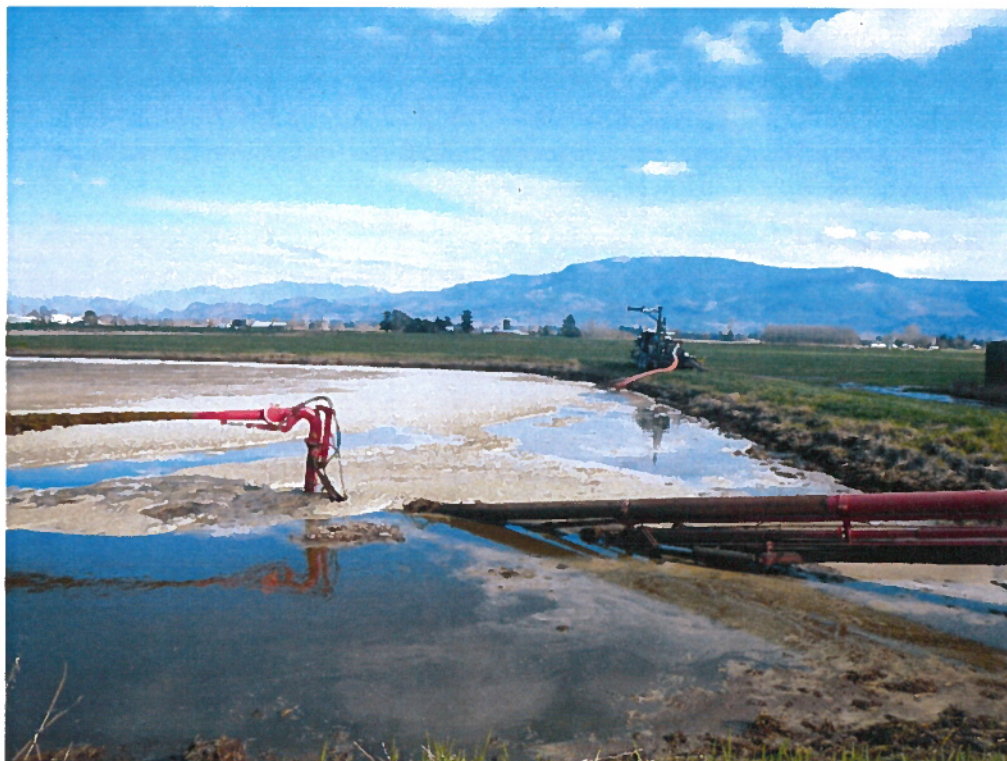
Photo 9 (DSCN0744): Eastern view of lagoon #2 at the heifer farm.

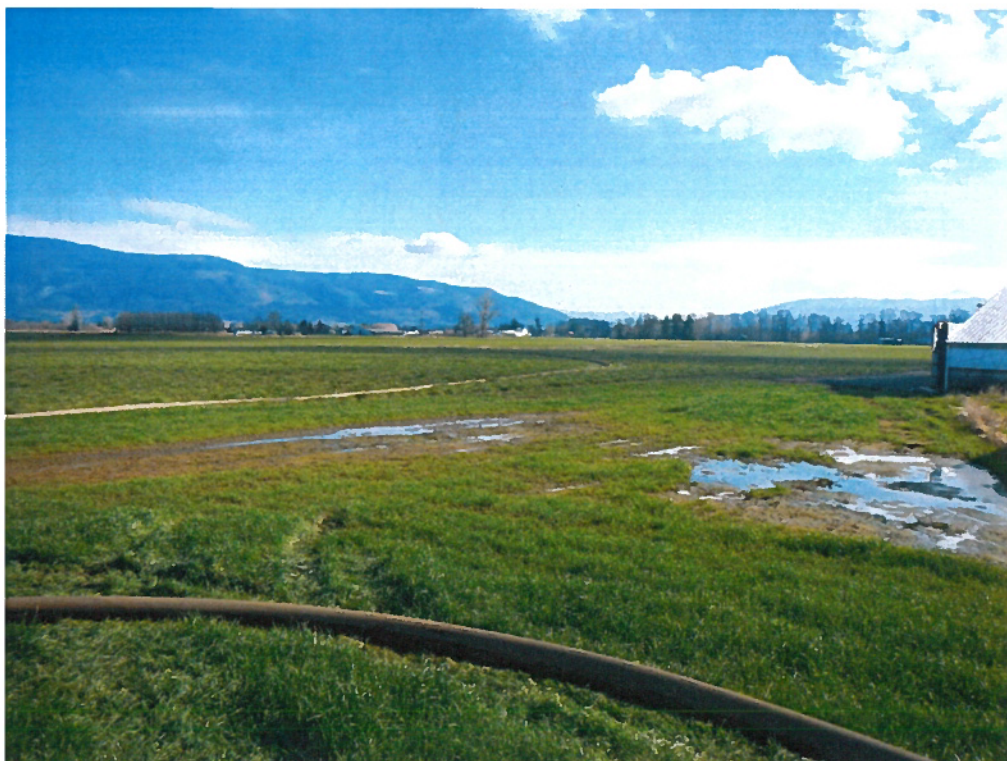
Photo 10 (DSCN0746): Southeastern view from the south end of lagoon #2. Note the pipe used for land application of liquid manure.

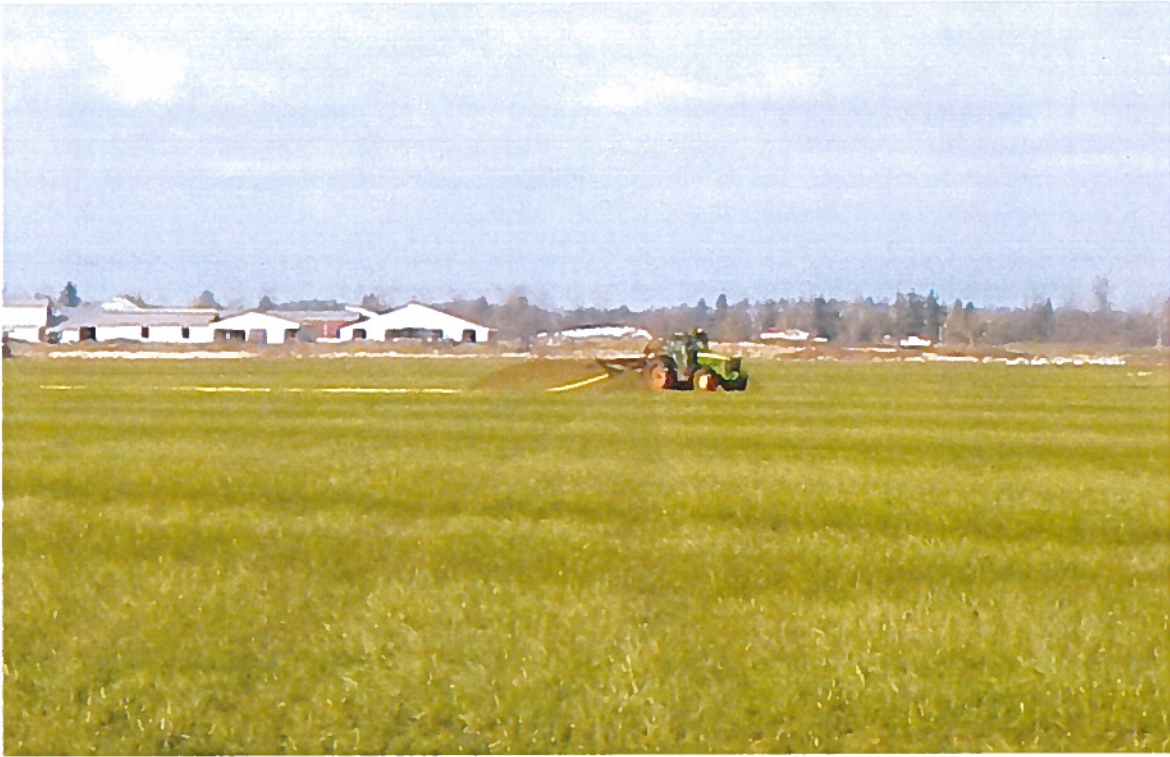
Photo 11 (DSCN0750): Northern view of the land application that was occurring at the time of inspection near the heifer facility. Note this photo has been cropped and enlarged.

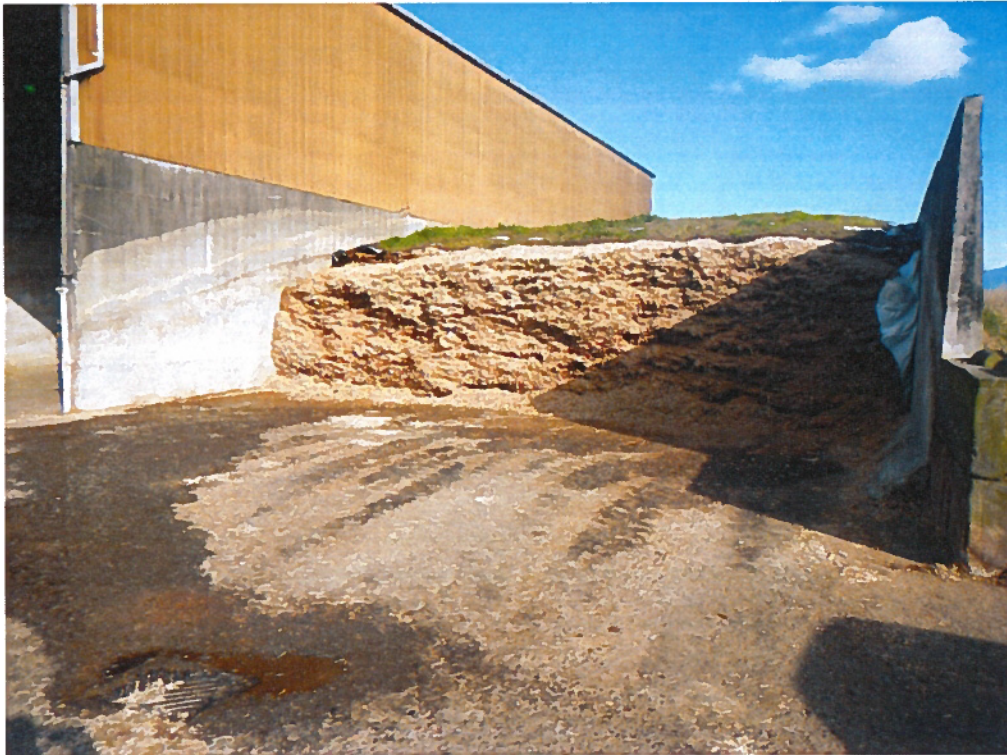
Silage was stored at both Vande Hoef dairies and the heifer farm (**Photo 12**). All silage piles were stored covered with a plastic sheet and some combination of tires and/or soil to weigh down the sheets. I noted that there was water ponded along the perimeter of the silage pile at the heifer farm (**Photos 7 & 8**). The ponded water stretched from the east side of the silage storage area to the northwest corner of the heifer barn and further west to within approximately 20 ft. of the ditch on the west side of the property. According to Mr. Vande Hoef, the water is the result of runoff from both the roof on the heifer barn

Photo 12 (DSCN0751): Silage storage area at Vande Hoef Dairy #2. Silage leachate drains to the grate pictured and is routed to lagoon #3.

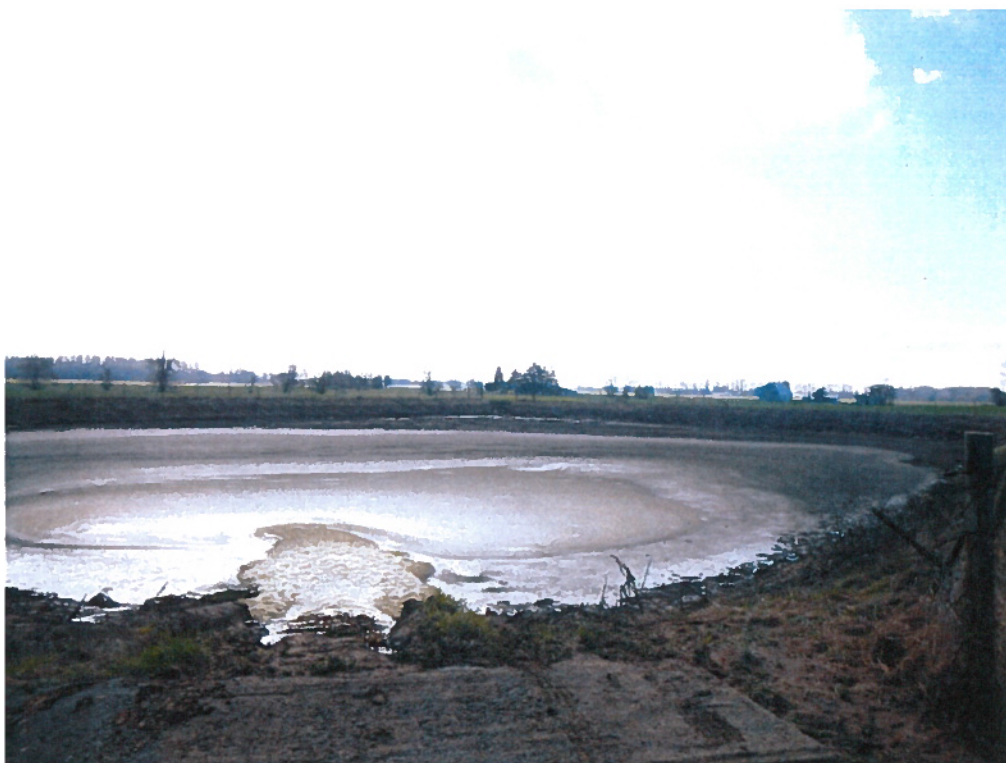
Photo 13 (DSCN0752): Southwestern view of lagoon #3 located at Vande Hoef Dairy #2.

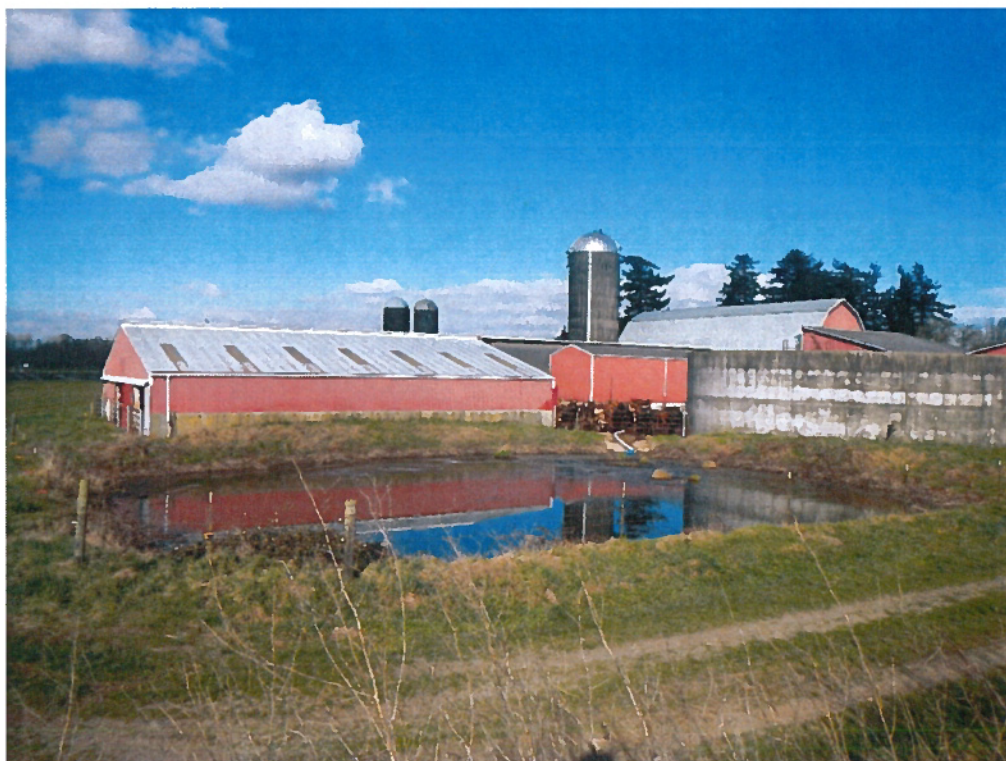
Photo 14 (DSCN0755): Northeastern view of the storage pit at Vande Hoef Dairy #2.

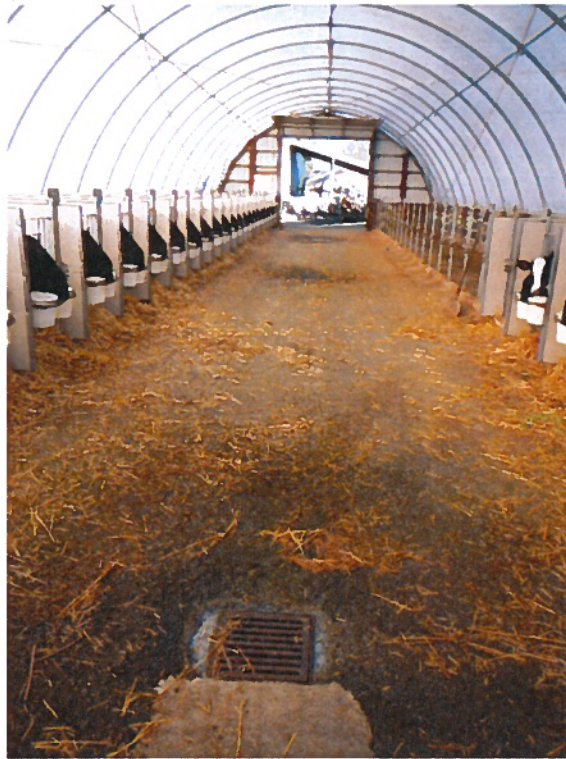
Photo 15 (DSCN0756): Southern view from inside a barn at the calf farm. The drain pictured is routed to lagoon #4.

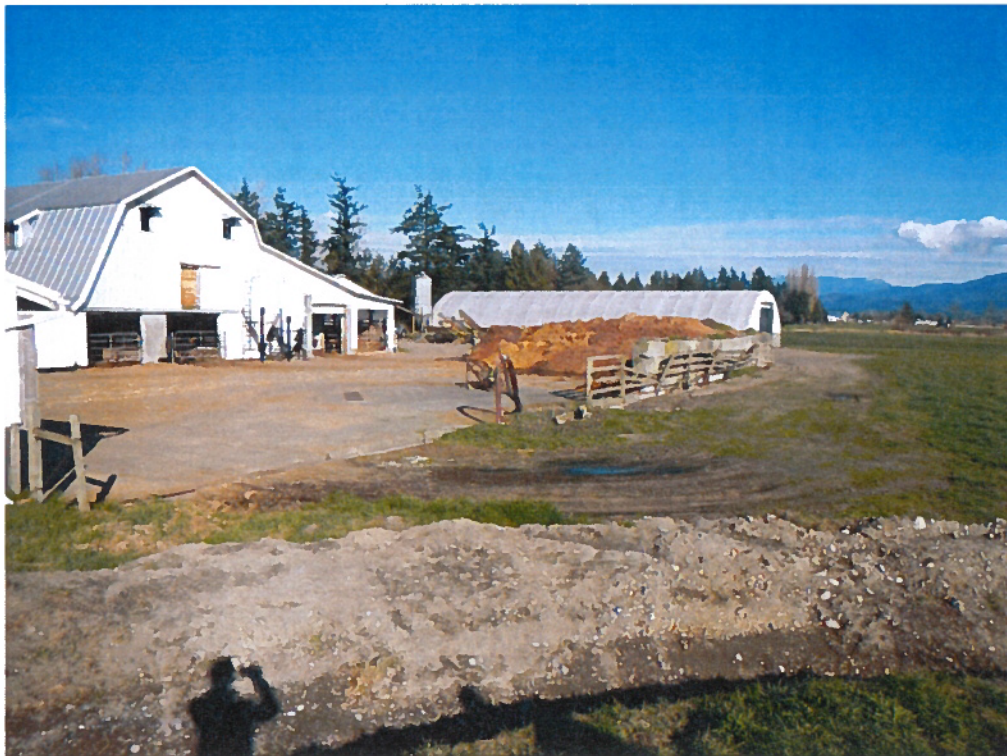
We then traveled to the calf farm. Drains inside the calf barns are routed to an underground tank and then pumped to lagoon #4 (**Photos 15 & 17**). Solids are scraped to a pile on the south side of the barns (**Photo 16**).

Photo 16 (DSCN0758): Northeastern view of the Vande Hoef calf farm.

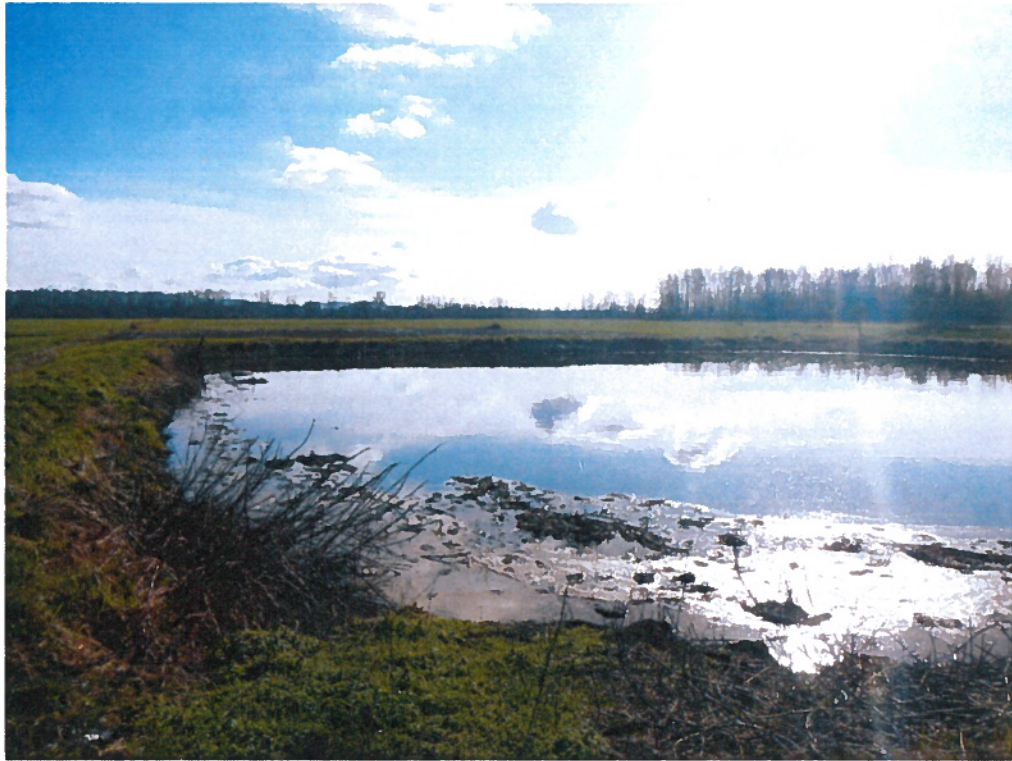
Photo 17 (DSCN0759): Southern view of lagoon #4.

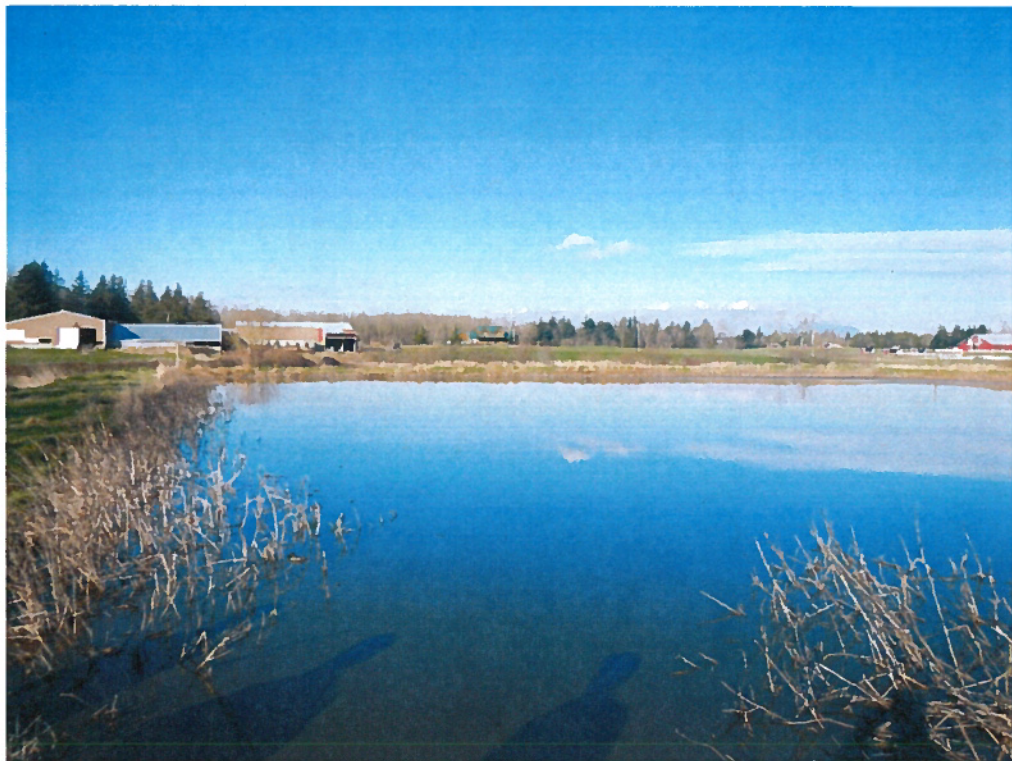
Finally we visited lagoon #5 (**Photo 18**). According to Mr. Vande Hoef, he only leases the portion of the land with lagoon #5 and not the buildings or surrounding fields associated with the property. I noted that the water level in the lagoon was very high. Mr. Vande Hoef said this is the fullest it has ever been and cited the high amount of rain fall in the past week as being the cause. He pointed out the risers located at the corners of the lagoon where lagoon water can be pumped to and routed to the other lagoons when needed.

Photo 18 (DSCN0760): Northern view of lagoon #5.
